TROUBLESHOOTING THE FOAM/SKIN INSULATION EXTRUSION PROCESS

R.L. Silverman, Equistar Chemicals, LP
D.E. Roberts, Equistar Chemicals, LP

This article originally presented at The Wire Association International Technical Conference, October 1994

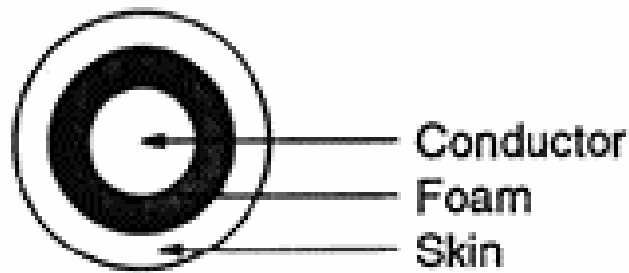
There are two layers in high density polyethylene (HDPE) foam/skin insulation for telephone singles, an inner layer of foamed polymer and a thin outer layer of solid polymer (Fig. 1). The thin solid outer layer, or skin, provides the mechanical properties and protects the foam. The inner foam layer decreases the electrical capacitance of the overall insulation, which allows closer spacing of the insulated conductors in the telephone cable. Air in the voids of the HDPE has a dielectric constant of 1.00 compared to the dielectric constant of approximately 2.32 for HDPE.

Fig. 1. Foam/Skin Construction
