TROUBLESHOOTING THE FOAM/SKIN INSULATION EXTRUSION PROCESS

R.L. Silverman, Equistar Chemicals, LP
 D.E. Roberts, Equistar Chemicals, LP

This article originally presented at The Wire Association International Technical Conference, October 1994

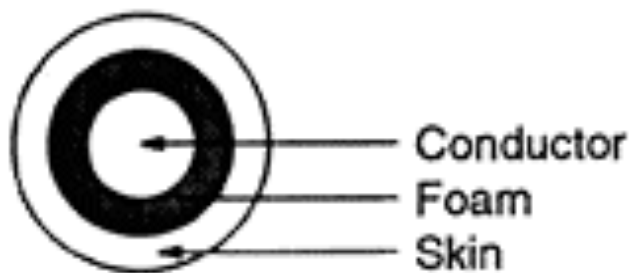
Fig. 1. Foam/Skin Construction

There are two layers in high density polyethylene (HDPE) foam/skin insulation for telephone singles, an inner layer of foamed polymer and a thin outer layer of solid polymer (Fig. 1). The thin solid outer layer, or skin, provides the mechanical properties and protects the foam. The inner foam layer decreases the electrical capacitance of the overall insulation, which allows closer spacing of the insulated conductors in the telephone cable. Air in the voids of the HDPE has a dielectric constant of 1.00 compared to the dielectric constant of approximately 2.32 for HDPE.
